Subject: Department of Natural Resources Washington Geological Survey,
School Seismic Safety Assessment Project, Contract No. AE 410 -
Seismic Evaluation for **East Valley (Yakima) School District**

School Buildings Evaluated in the East Valley (Yakima) School District

Table 1-3. Identified Structural Seismic Deficiencies for East Valley (Yakima) East Valley Central Middle School 6th Grade Building

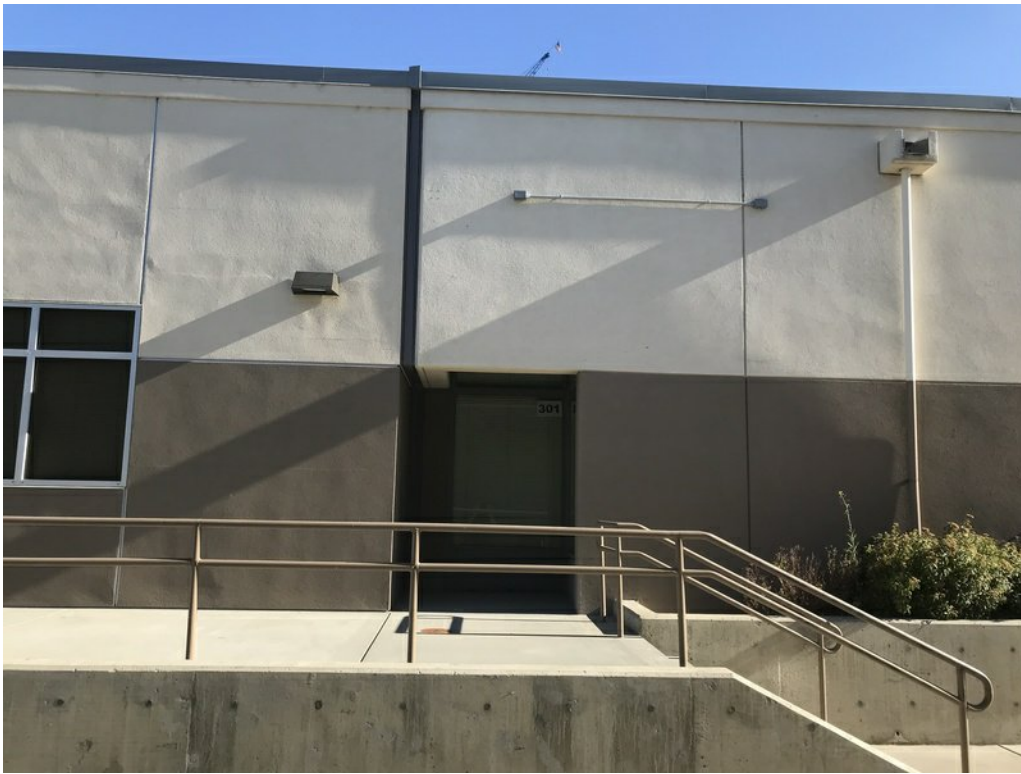
Figure 1-5. Seismic Joint Between Original Building and Addition - Exterior

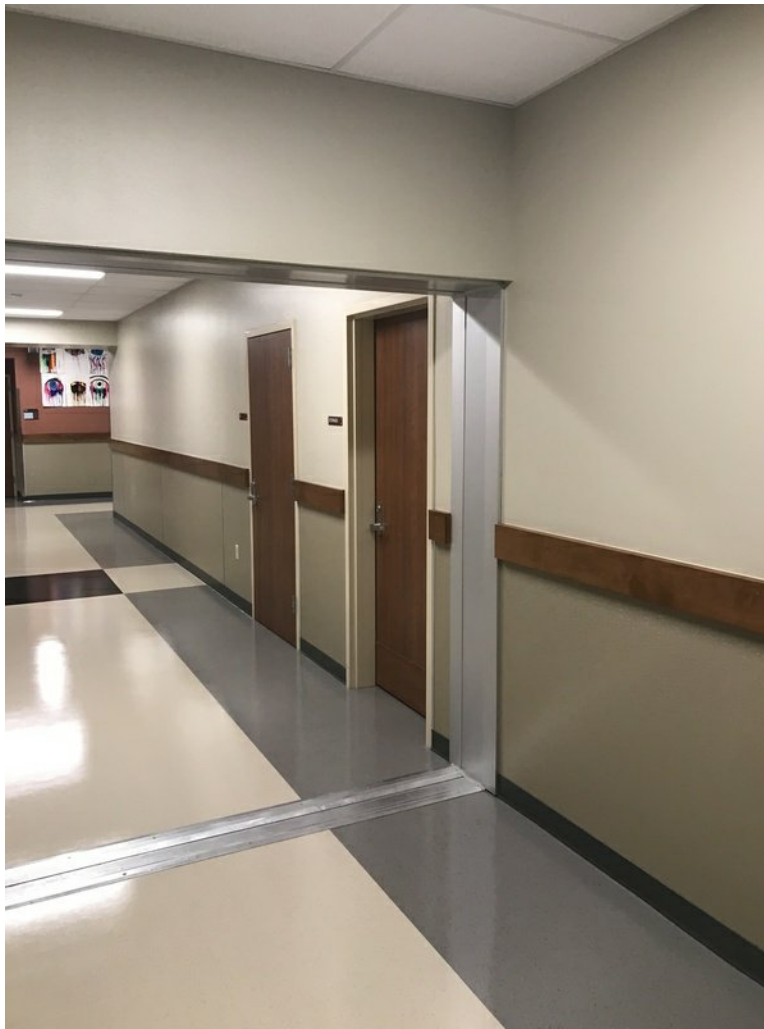
Figure 1-6. Seismic Joint Between Original Building and Addition - Interior

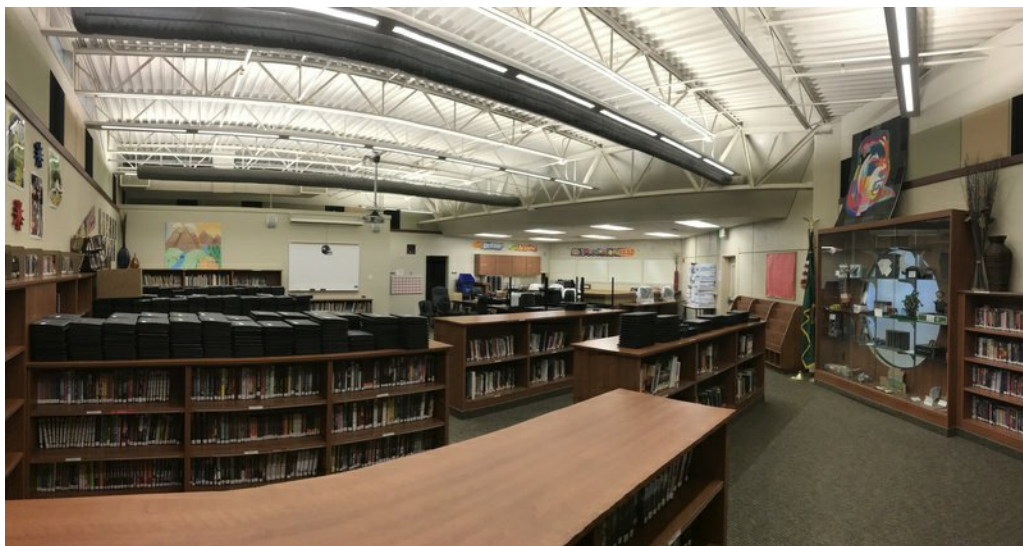
Deficiency	Description
LSS-5 Sprinkler Ceiling Clearance. HR-not required; LS-MH; PR-MH.	Inadequate penetration clearances at panelized ceilings for fire suppression devices. Provide clearance around sprinkler head or provide flexible lines between horizontal piping and sprinkler heads.
CF-2 Tall Narrow Contents. HR-not required; LS-H; PR-MH.	Anchorage required for tall narrow contents more than six feet high to provide overturning restraint.
ME-3 Tall Narrow Equipment. HR-not required; LS-H; PR-MH.	Anchorage required for tall narrow equipment more than six feet high to provide overturning restraint.

Figure 1-8. Library with Inadequate Sprinkler Head Penetration Clearance and Unknown Light Fixture Bracing at Low Ceiling

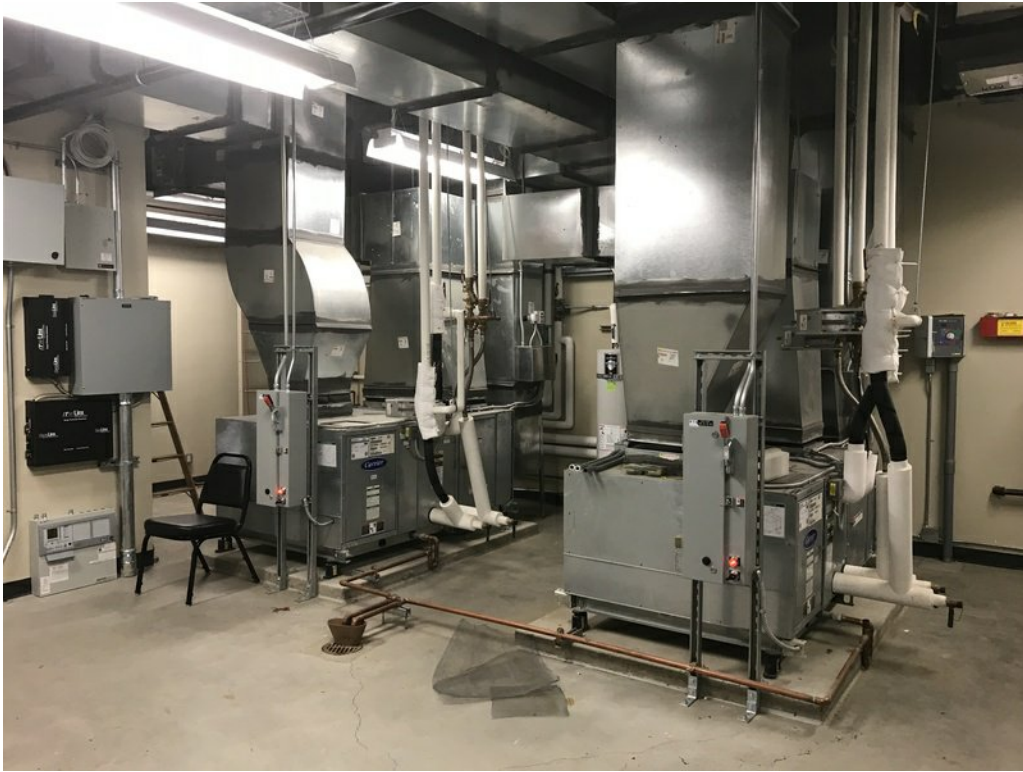
Figure 1-10. Mechanical Room with Unanchored Units

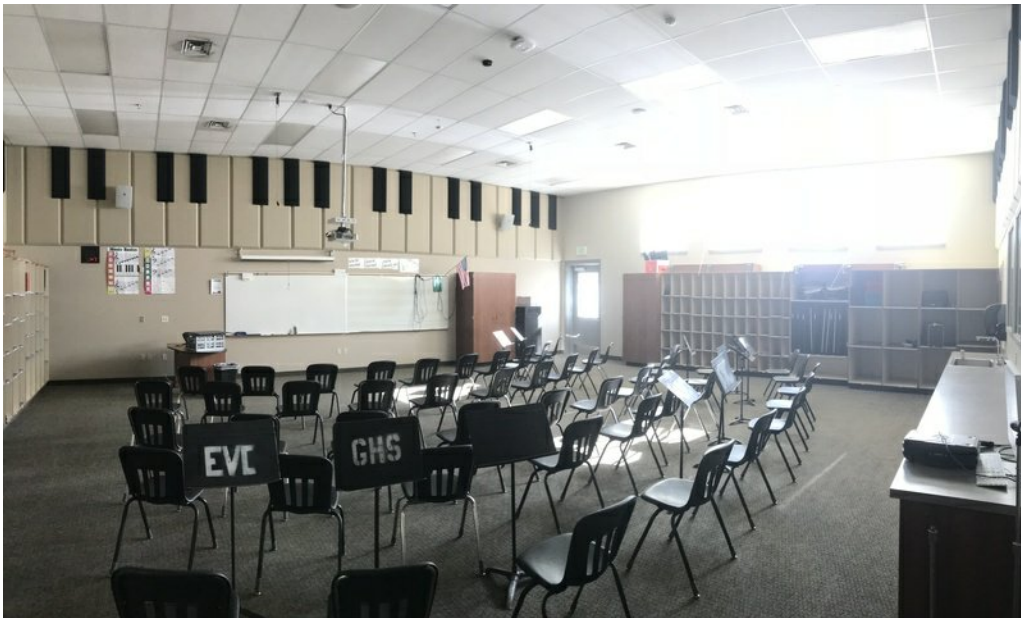
Figure 1-7. Music Room with Unknown Light Fixture Bracing

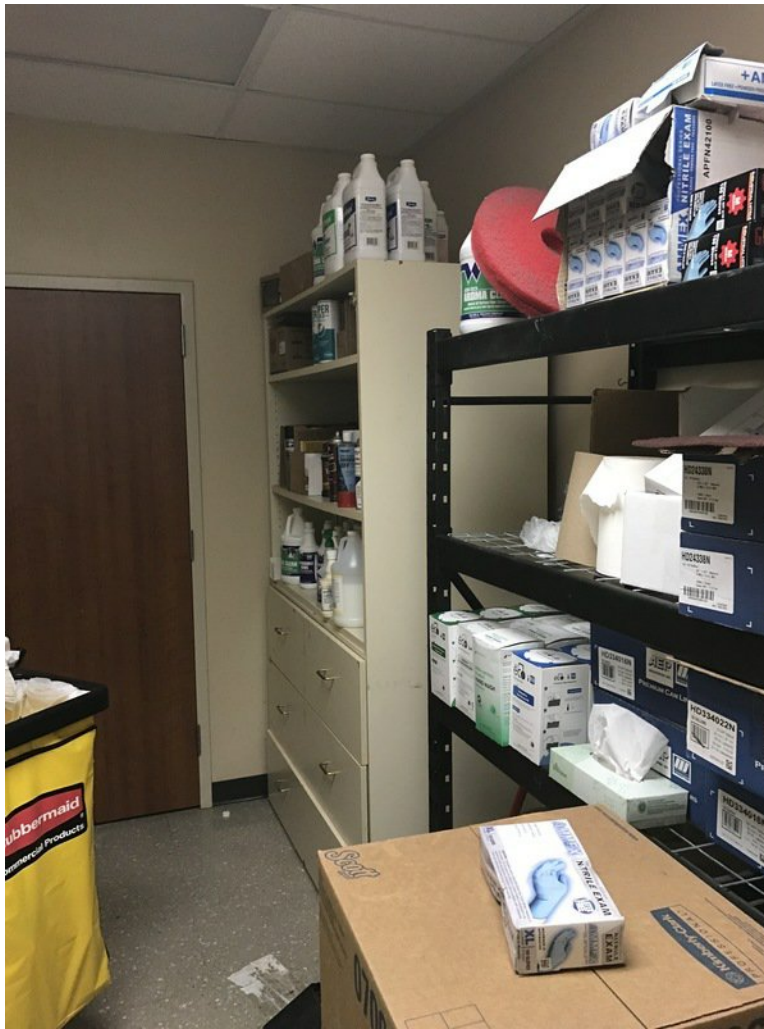
Figure 1-10. Unbraced Tall Narrow Contents, Typical Throughout

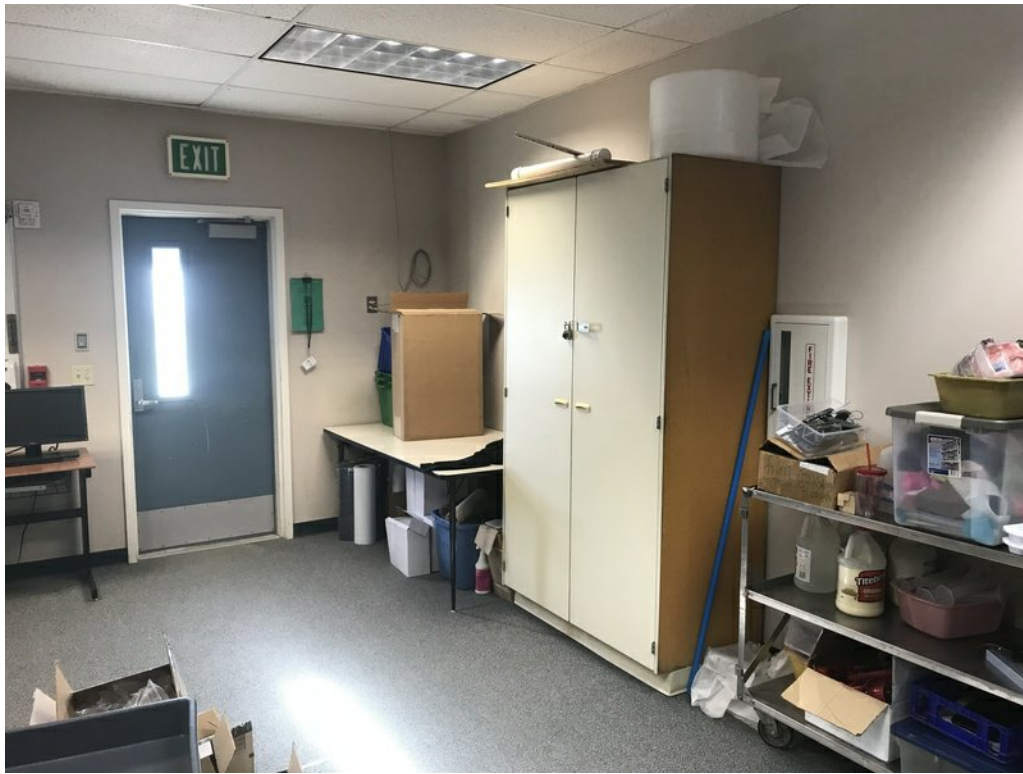
Figure 1-5. Unbraced Nonstructural Components in Entry

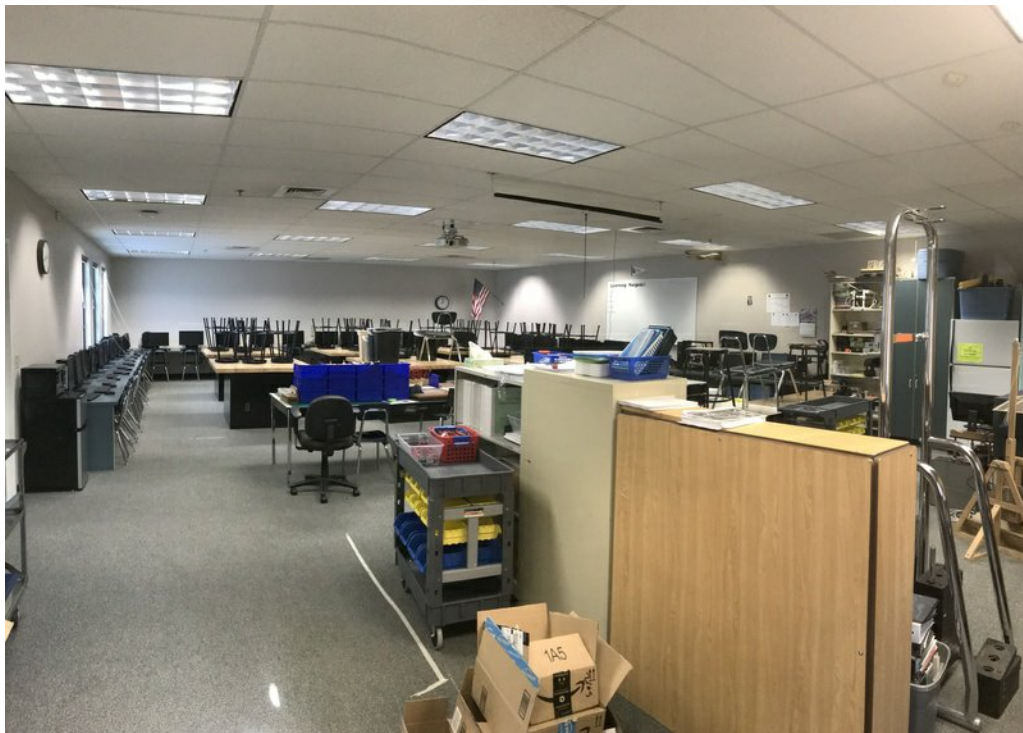
Figure 1-6. Classroom 404 with Unknown Light Fixture Bracing, Typical Throughout Building

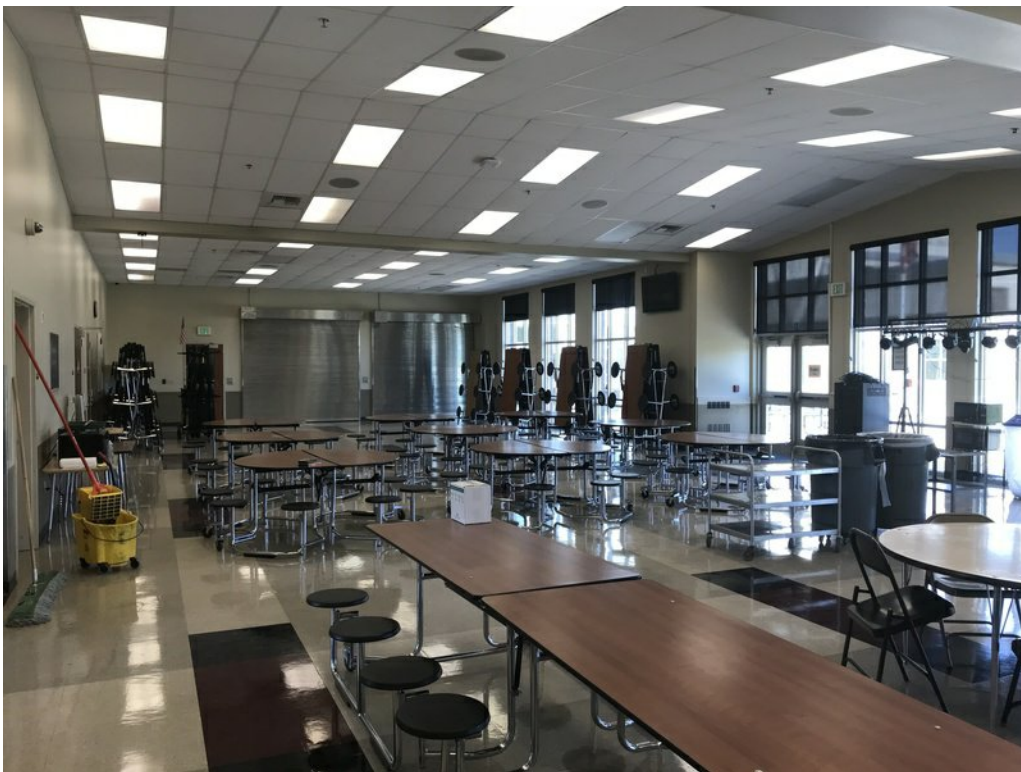
Figure 1-6. Commons with Unknown Light Fixture Bracing

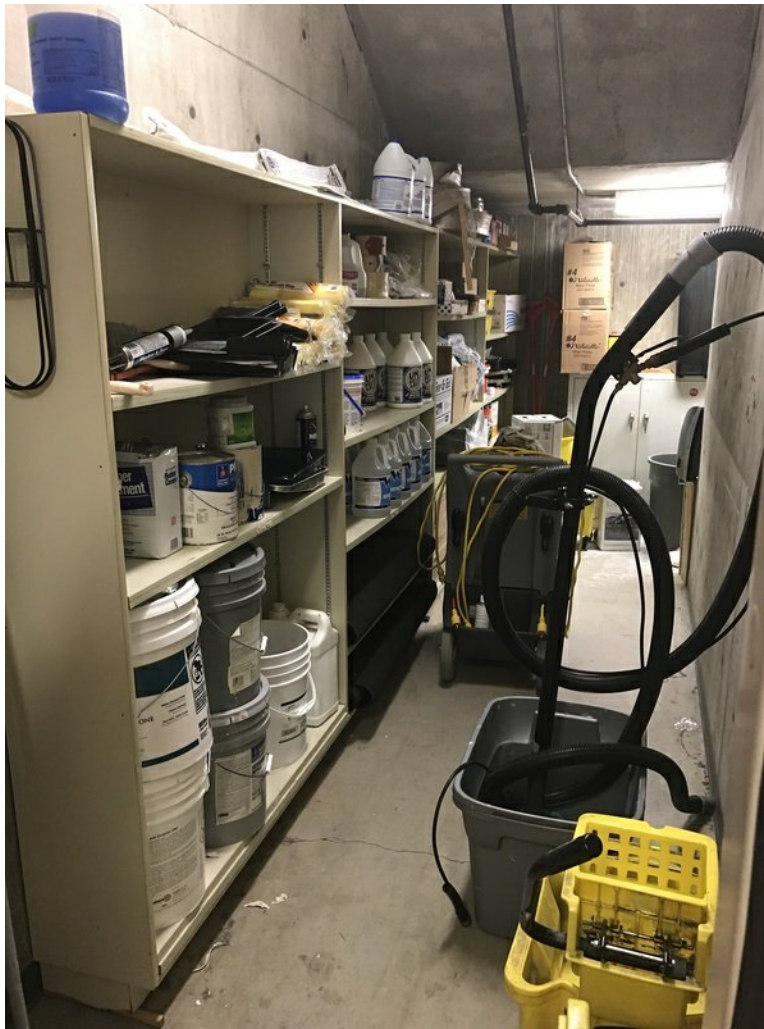
Figure 1-10. Unrestrained Hazardous Material Storage

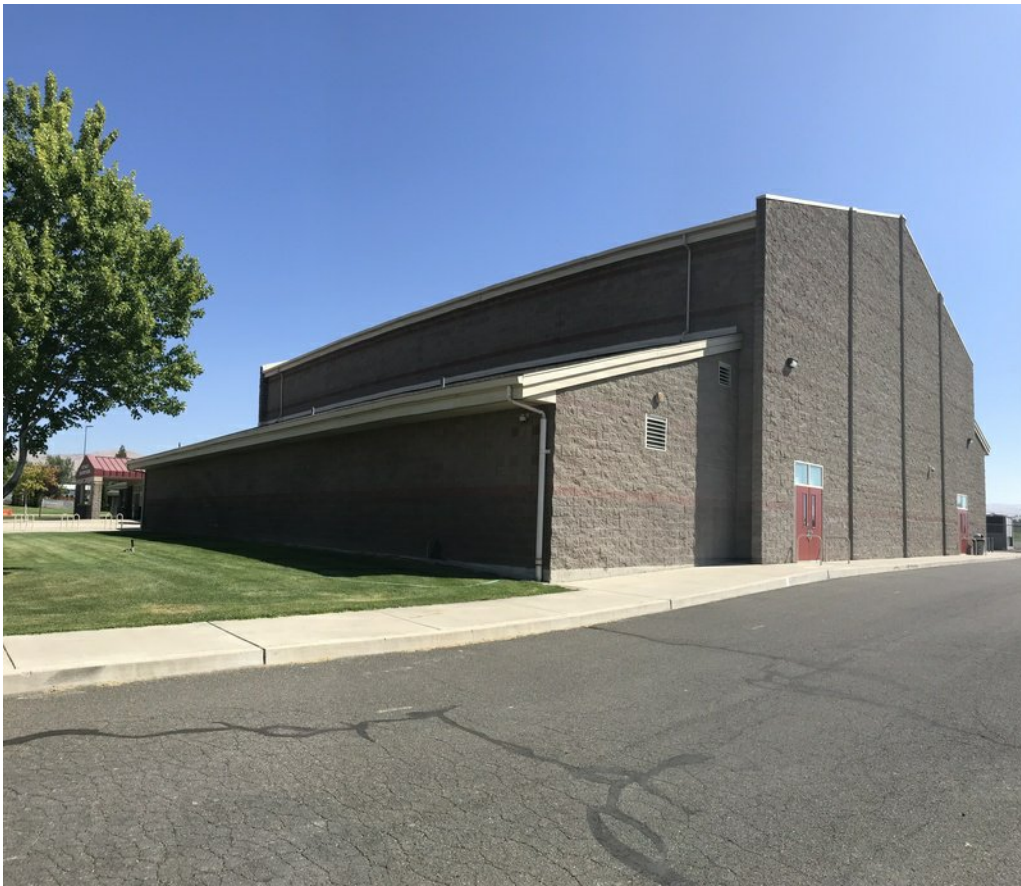
Figure 1-1. East Valley Elementary School Main Entrance - West Exterior

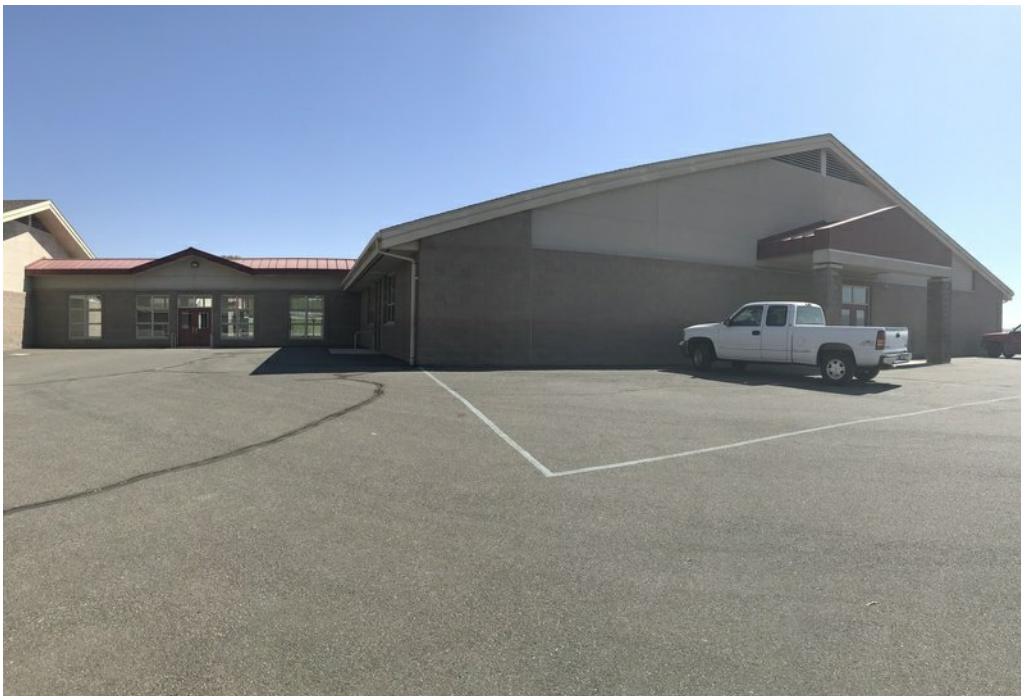
Figure 1-2. East Valley Elementary School Gymnasium - Southwest Exterior

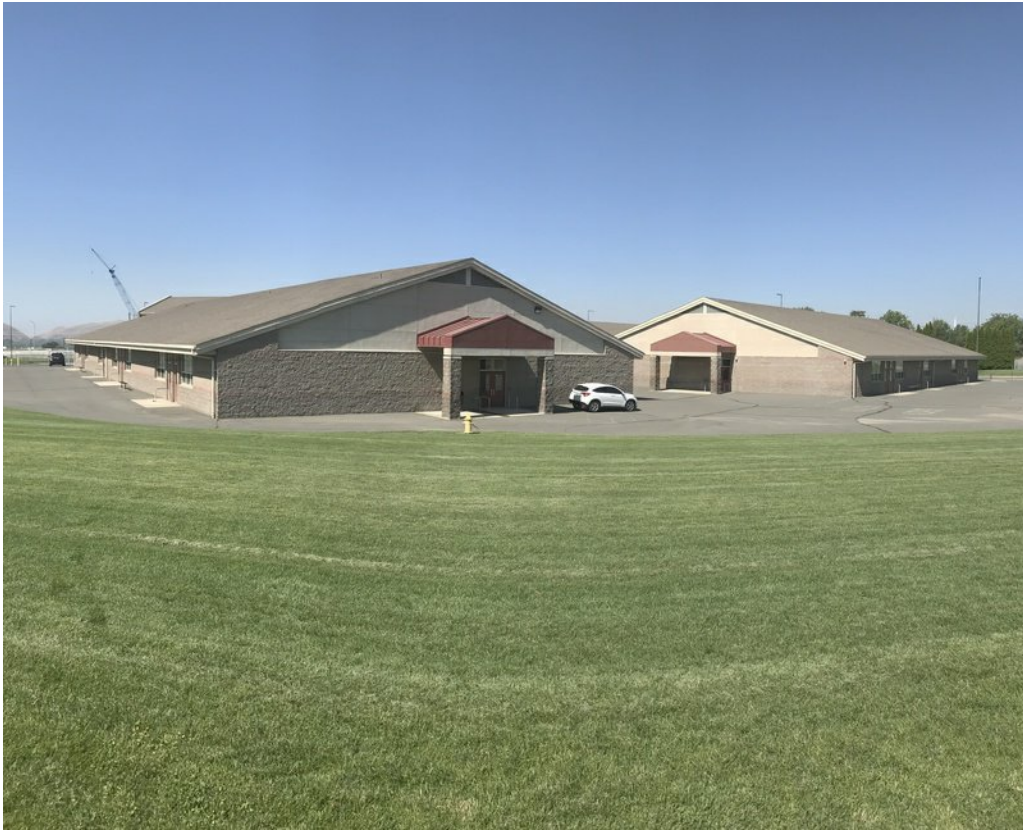
Figure 1-3. East Valley Elementary School 300 Wing - Southwest Exterior
